Bissell PowerLifter Brush Belt Replacement

This is a quick repair and will ensure that your Vacuum cleaner will work as it should.

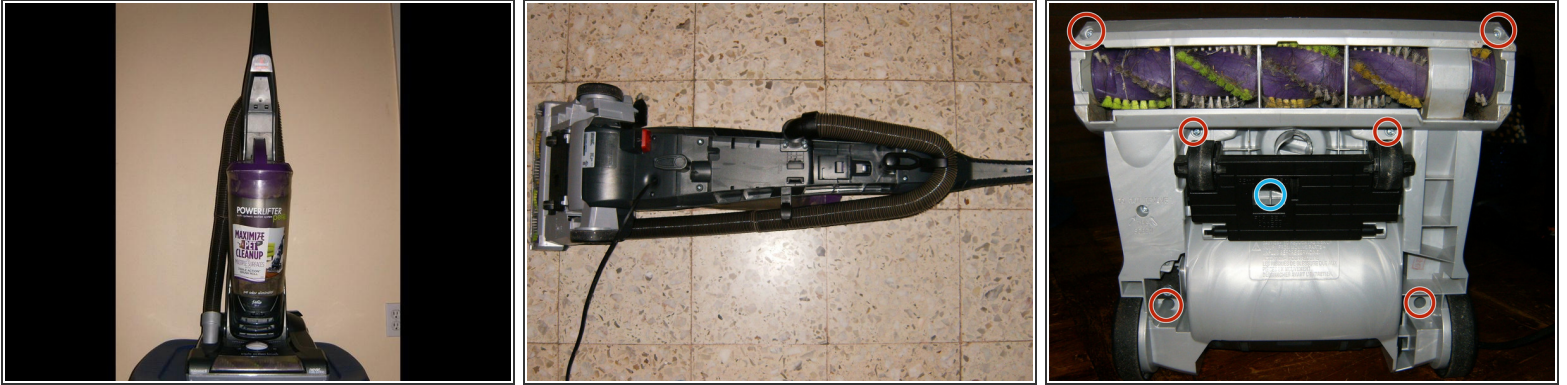
Step 1 — Brush Belt

- Here is the Bissell vacuum cleaner. The front brushes did no longer turn.
- Unplug the vacuum and turn it over so the bottom of the vacuum can be accessed
- There are a total of 7 Phillips head screws that need to be removed.
 - One of these screws is behind the height adjustment plate. It must be removed to gain access.
